LEAD AND ASBESTOS SURVEY OF EAST MARTELLO BATTERY NVSTA KEY WEST, FLORIDA

INSPECTION PERFORMED BY NAVY PUBLIC WORKS CENTER PENSACOLA, FLORIDA

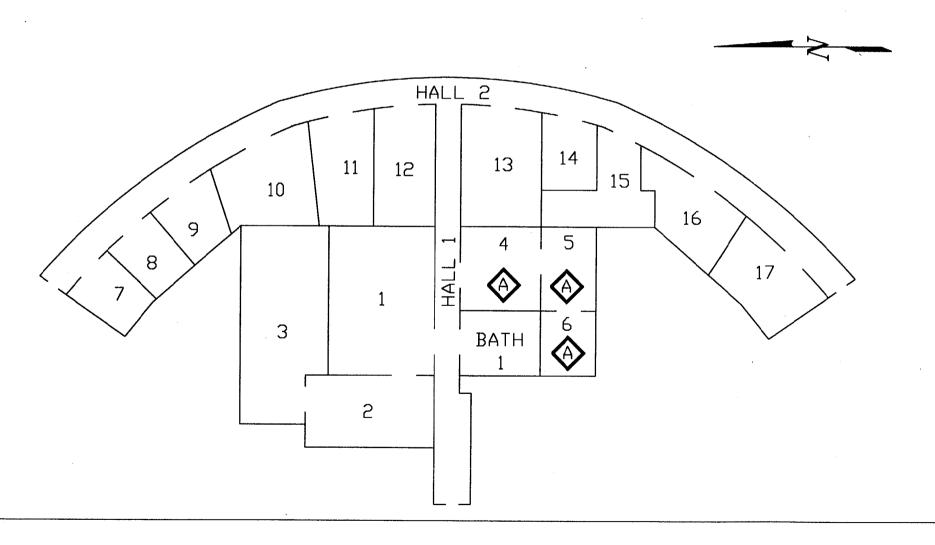
EAST MARTELLO BATTERY

HOMOGENEOUS MATERIAL

SAMPLE #

AREA

FLOOR TILE, BROWN, 9"

EM001, EM002, EM003

EMO04

NOTE:

HOMOGENEOUS AREA B IS VISIBLE

VENT PIPE, 12"

ON TOP OF THE STRUCTURE
